Inspection Report

Property Address:
123 House Street
SAINT LOUIS MO 63116

CANDID HOME INSPECTION SERVICE, LLC.

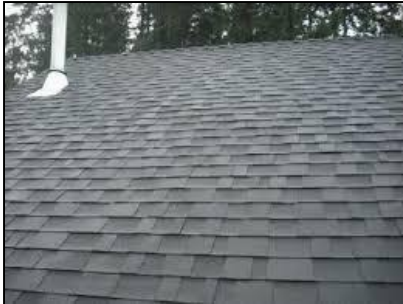
1.0 Item 1(Picture) Right Rear Roof

1.0 DOES THE ROOF COVERING APPEAR TO BE IN SERVICEABLE CONDITION

Roof Overview: Roof covering overall appears to be in satisfactory condition for age and type at time of inspection.

Note: *Roof covering should be visually checked in spring and fall for any visible missing shingles, damaged covering or other defects.*

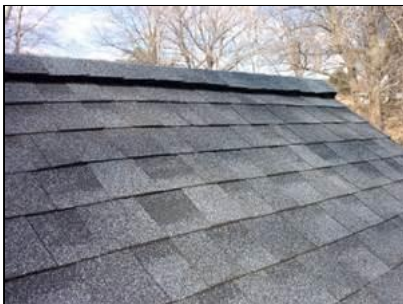
1.2 Item 1(Picture) Ridge Vent

1.2 ADEQUATE VENTILATION

Ventilation for the roof appears adequate in keeping with standard building practices.

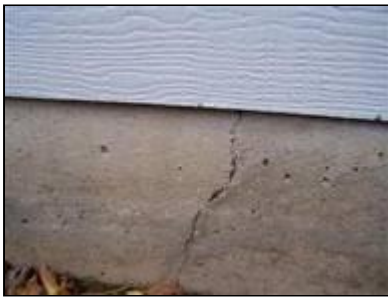
2.2 Item 1(Picture)

2.2 FOUNDATION WALLS AND MORTAR JOINTS (exterior)

Cracks observed in front exterior foundation and not considered significant at time of inspection. Client is reminded it is not possible during a cursory review to ascertain whether a crack is stabilized. When no significant displacement is present we advise the crack conditions be monitored.

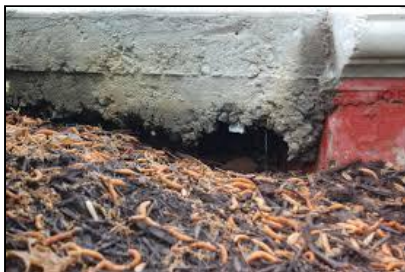
3.0 Item 1(Picture)

3.0 WHAT IS THE CONDITION OF PORCH OR PATIO

Voids detected under front entry pad. Properly filling voids to reduce soil erosion and unwanted settlement is needed. Recommend further review as deemed necessary. **Maintain & Monitor:** Client should monitor caulk application at front entry pad & steps aligning foundation to reduce unwanted moisture penetration and considered part of homeowners maintenance.

Voids detected under front entry pad. Properly filling voids to reduce soil erosion and unwanted settlement is needed. Recommend further review as deemed necessary. **Maintain & Monitor:** Client should monitor caulk application at front entry pad & steps aligning foundation to reduce unwanted moisture penetration and considered part of homeowners maintenance.

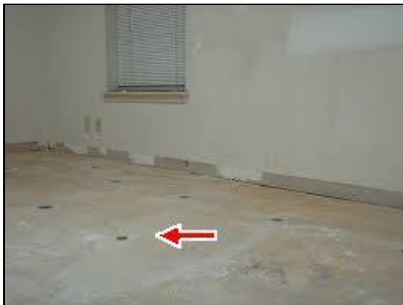
5.4 Item 1(Picture)

5.4 CONDITION OF GARAGE FLOORING

Evidence of a mudjacking repairs at garage slab. Unable to determine the long term effectiveness of repairs. Client should obtain a history from sellers and any transferrable warranties that may be applicable.

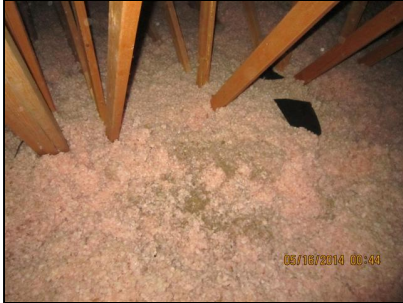
8.1 Item 1(Picture) Attic Insulation

8.1 IS INSULATION IN ATTIC

Providing additional insulation is suggested as an energy conservation measure and 12-15 inches is recommended.

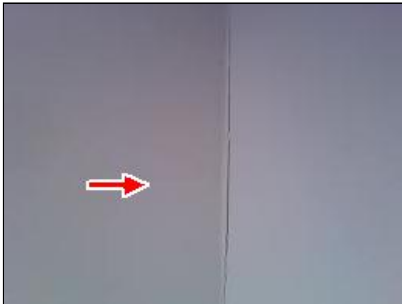
11.1 Item 1(Picture) Living room Ceiling

11.1 CEILING

Typical cracks noted at dining room, and living room ceilings. Conditions are not considered significant at time of inspection and should be monitored.

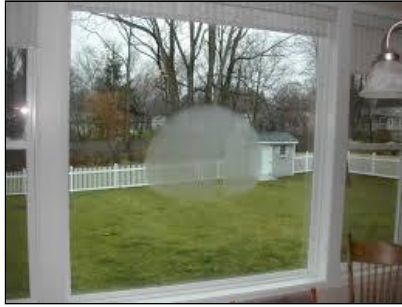
11.5 Item 1(Picture) Master Bedroom Window Condensation

Condensation stains or otherwise obscurity was observed in master bedroom **and** dining room thermopane windows which has reduced the visibility of the windows and considered a defective condition. To restore the visibility replacement of the windows is required. A qualified contractor familiar with window pane replacement or otherwise restoration should be retained to further evaluate and make corrections as deemed necessary.

Condensation stains or otherwise obscuring was observed in master bedroom **and** dining room thermopane windows which has reduced the visibility of the windows and considered a defective condition. To restore the visibility replacement of the windows is required. A qualified contractor familiar with window pane replacement or otherwise restoration should be retained to further evaluate and make corrections as deemed necessary.

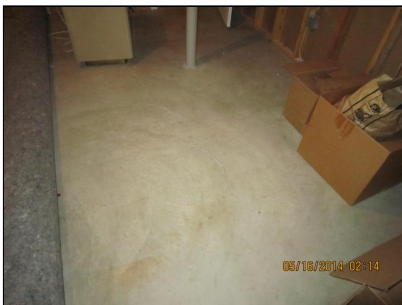
15.3 Item 1(Picture) Common Crack Basement Slab

15.3 SLAB CONDITIONS

Common cracks visible at basement slab and not considered significant at time of inspection. Conditions should be monitored.

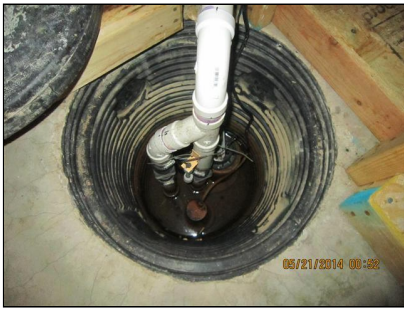
15.5 Item 1(Picture) Sump Pump

Sump pump tested and operational at time of inspection.

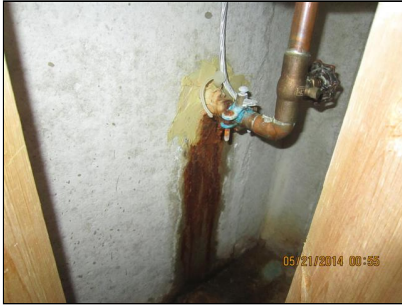
16.0 Item 1(Picture) Leak At Main Water Shutoff

Active moisture visible where main water line penetrates the foundation. Sealing is needed and an injection repair is the correction of choice. Recommend further review.

Active moisture visible where main water line penetrates the foundation. Sealing is needed and an injection repair is the correction of choice. Recommend further review.
